Confidential Inspection Report

10104 W. 126th St
Overland Park, KS 66213

06/04/2020

The Doe Inspection

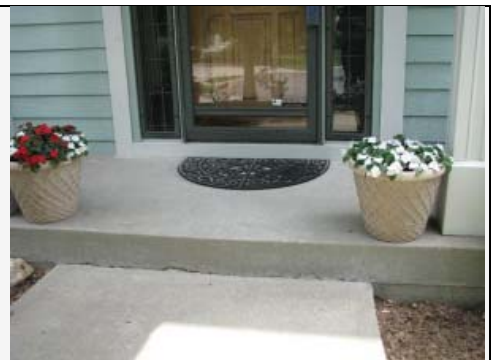
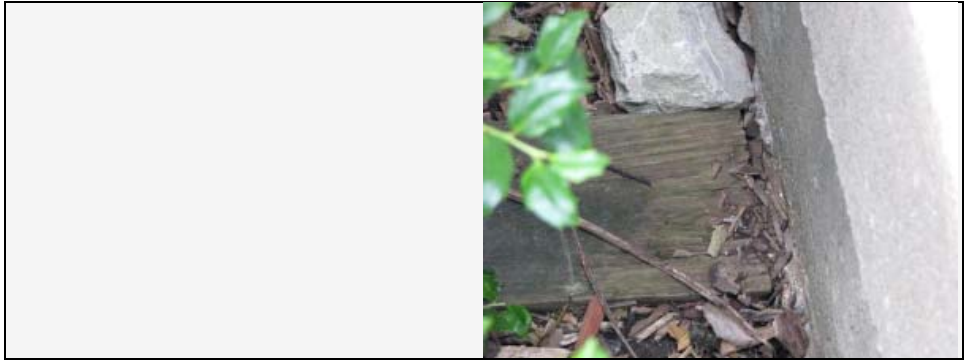
Poor drainage noted. Water, if it is not allow to drain away from the porch, can cause damage, sinkage, heaving and cracking. The water should drain off and away from this area.

Wood laying in the dirt next to the front porch is a termite hazard. Removal is advised.

There appears to have been a termite treatment performed on this building. This is indicated by the drill marks in the concrete porch and other areas of the building. See a certified termite

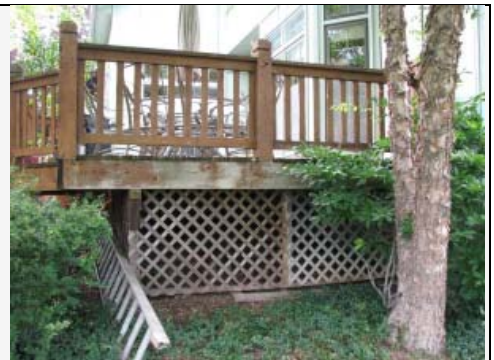
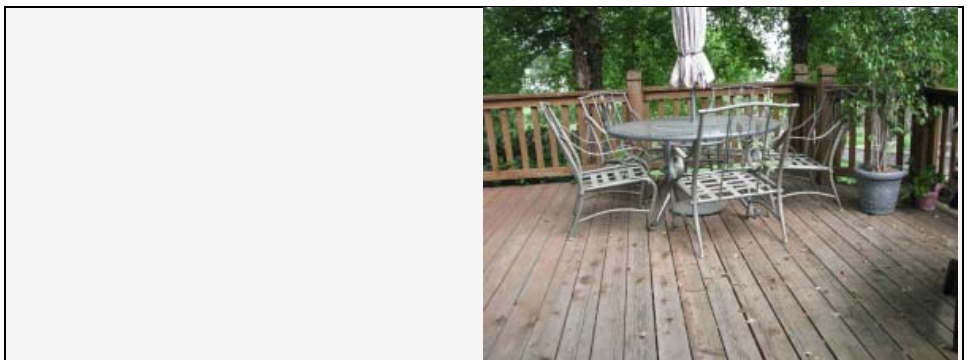
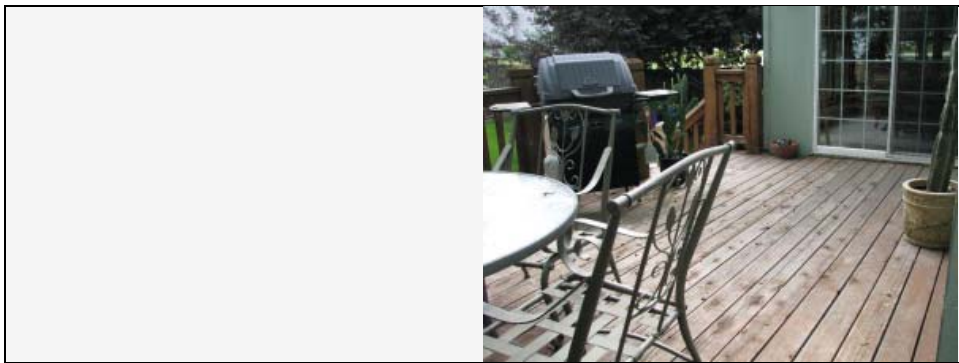
This deck is in poor condition and is nearing the end of its normal life. Maintenance and repairs are needed to extend the life of this deck and make it safe.

Loose decking and nails noted throughout.

This deck is installed to the structure without proper attachments. Nailing the deck to the structure is unsafe and could fail, causing the deck to fall. We recommend that the proper lag bolt attachments be installed to give this deck the proper shear strength for safety.

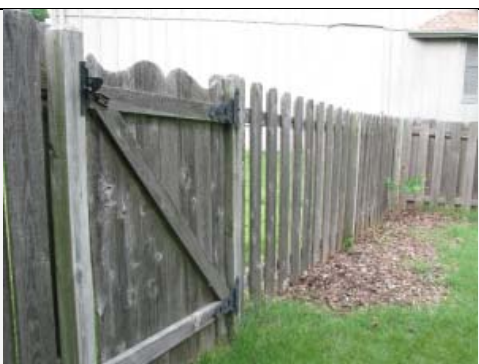
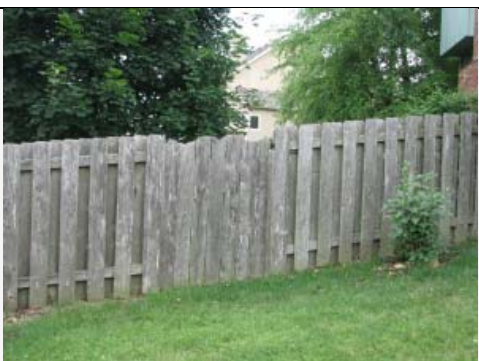
The wood fencing is of an age that damage and deterioration is common. This fencing is in need of maintenance and repairs for continued usage.

The hinging on the Northern deck is damaged. Repair is advised.

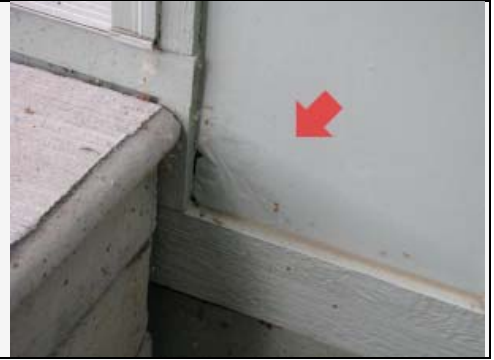
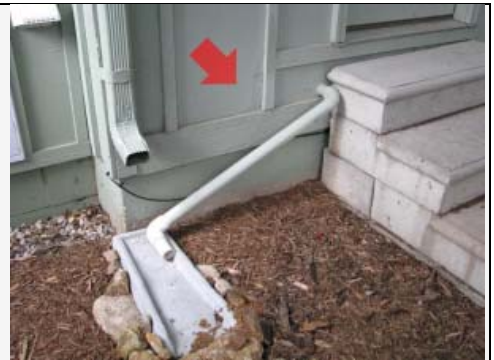
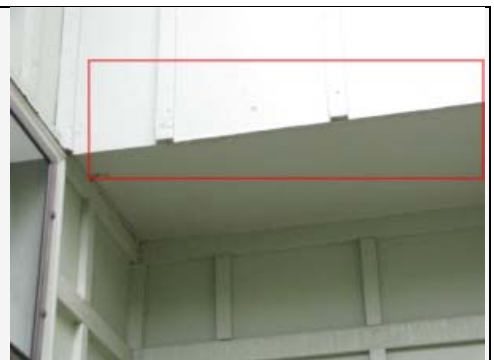
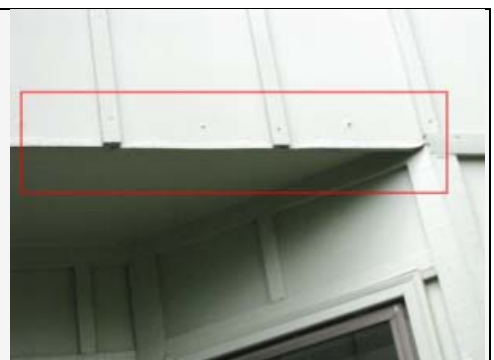
There is water damaged siding on both sides of the rear concrete steps leading to the laundry room door. Repair is needed or interior wall damage will occur.

Water damaged siding on the rear, over the deck area. Repair is advised.

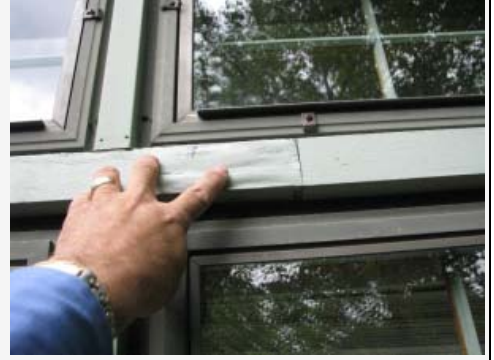
The wood trim, in several areas around the house, is in need of sealing and caulking. Joints and seams have opened up. While this is a normal part of the aging of the house, open seams and joints can allow water to penetrate into the walls and cause leaking in the building. Repair is recommended.

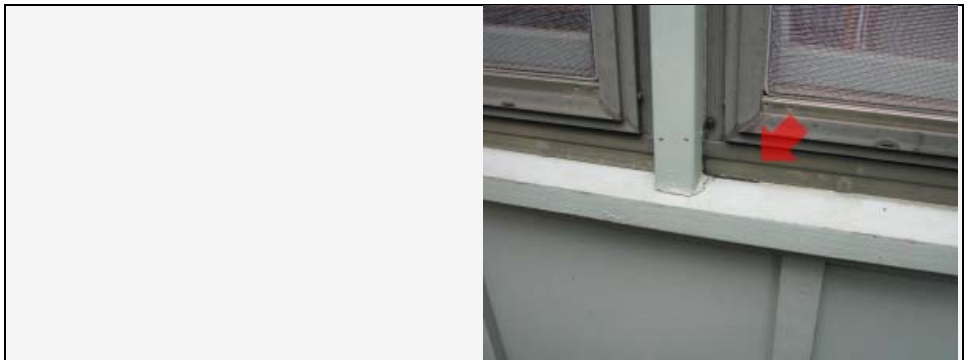
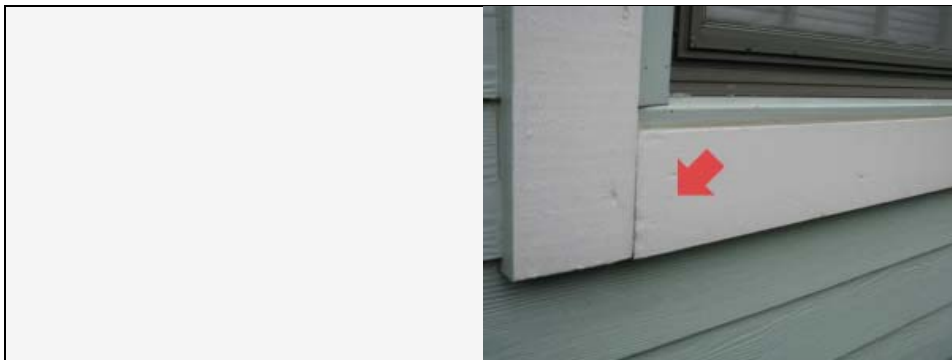
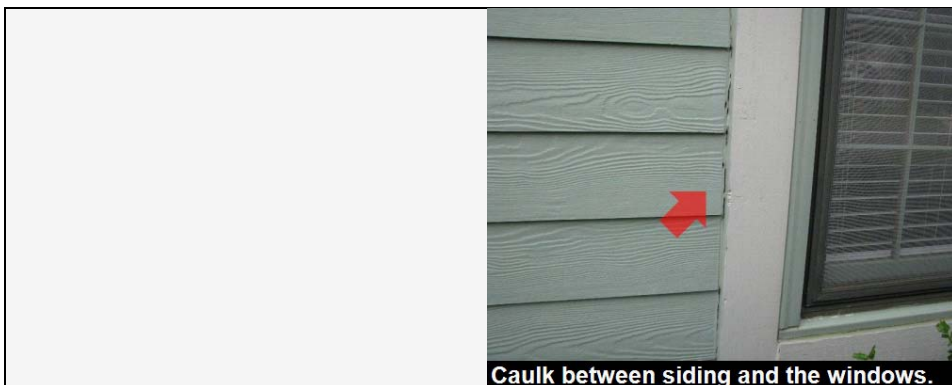
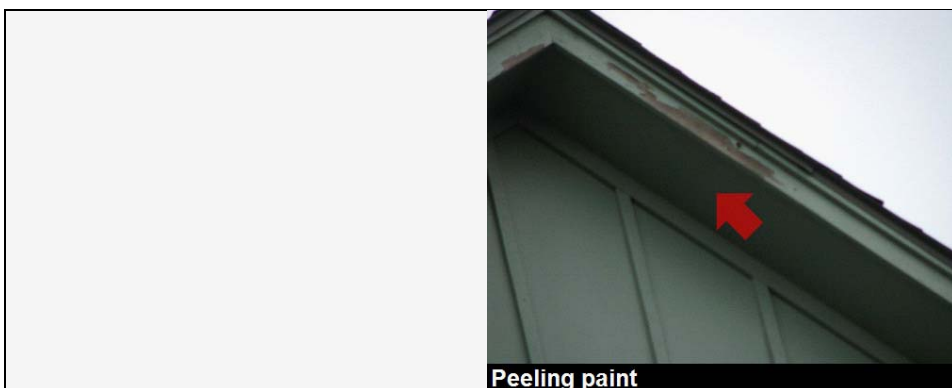
There is wood rot noted in several areas of the wood trim.. An example of this is in the horizontal window muntin on the rear deck windows, the bottom window trim on the West side garage windows, The horizontal muntin in the breakfast room windows and in the window sill in the breakfast room windows. Wood rot is caused by a mold and is a living organism. Replacement of the damaged wood recommended.

Several areas of the trim was in need of painting or refinishing. On the North fascia around the peak and around the South Chimney chase. Unprotected wood can allow the wood to be damaged.

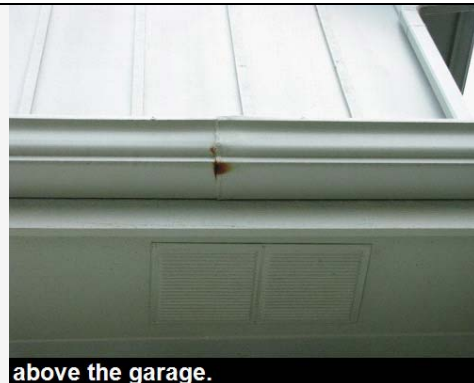
The guttering is the original and is starting to rust through in areas. Noted over the garage and in the NW area of the upper gutter. This guttering is nearing the end of it's life and will need repairs for continued operation.

above the garage.

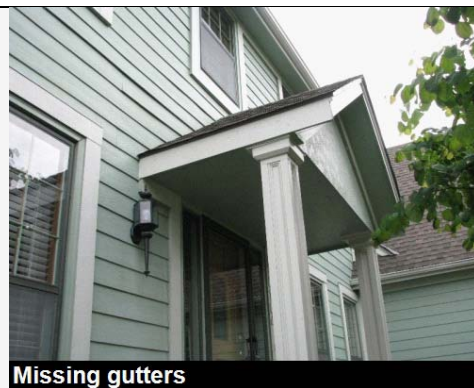
Missing the guttering on both sides of the front porch. Without these gutters, water is drainage too close to the front porch. This can cause to the porch and erosion of the grading. Recommend adding gutters to this location.

Missing gutters

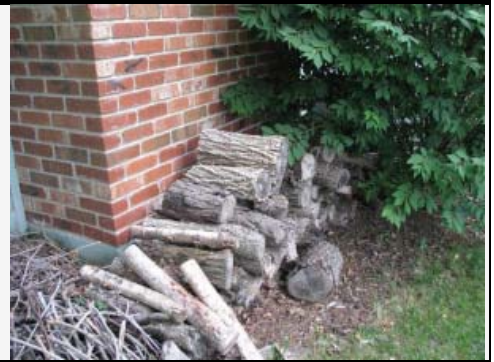
There are wood piles too close to the structure. Recommend that all wood piles be removed to a minimum 20' away from the structures. This is a termite and pest hazard.

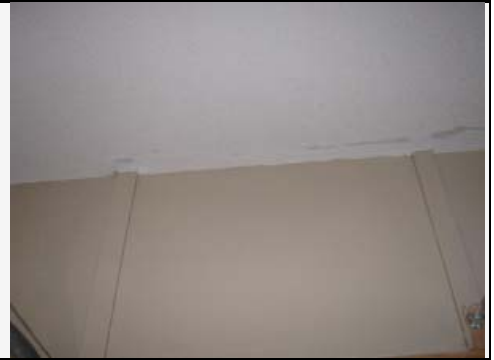
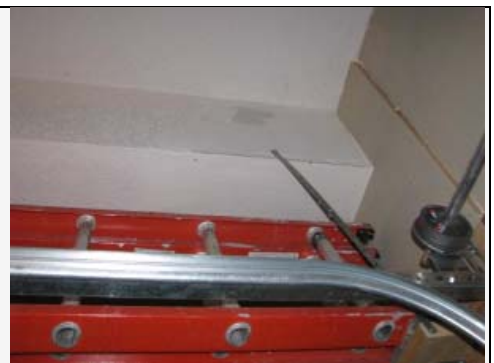
There have been repairs made to the ceiling above the single roll up door and in the wall board around the beam on the West side. Further investigation is advised.
--	---------------------------------------------------------------------------------------------------------------------------------------------------------------------

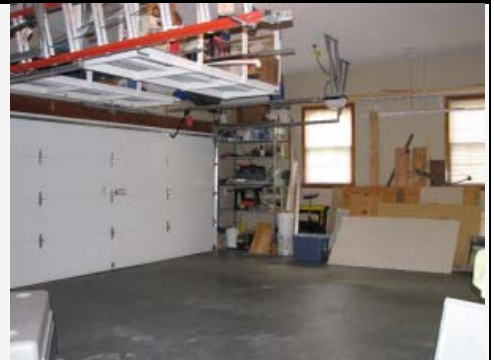
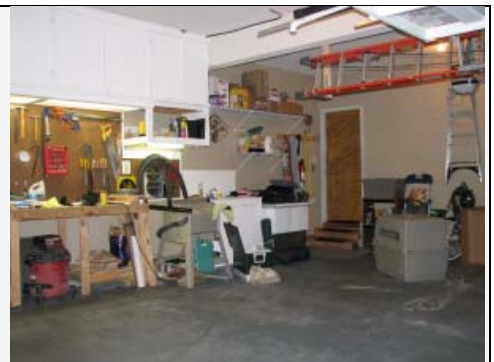
Damaged attic hatch in the garage.

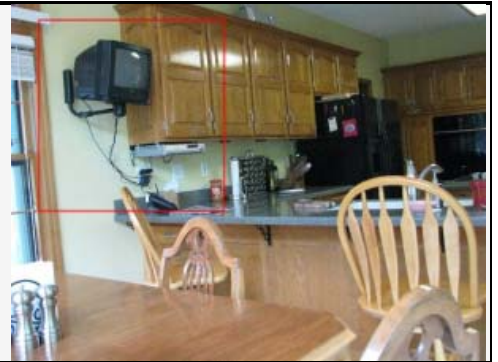
There is an installed TV mounted to the finished wall. Make sure that if this is removed, that the wall is repaired.

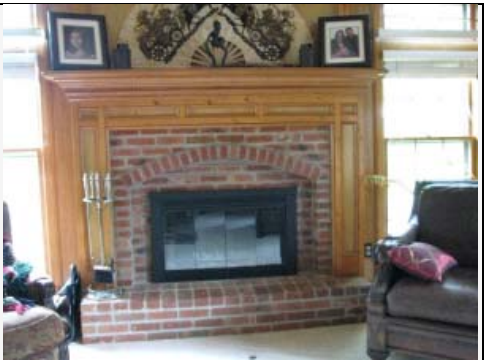
<i>CONDITION:</i>	The masonry chimney is in need of cleaning. Recommend review and repair by a chimney sweep.

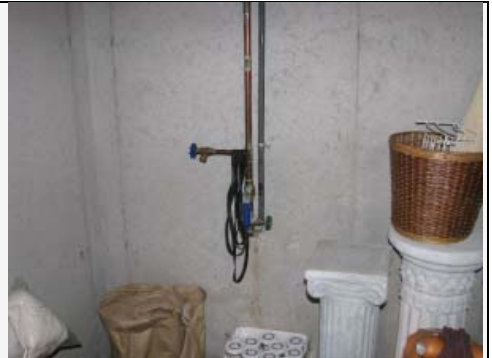
LOCATION:	Basement.
MATERIAL:	Copper, Main line is 3/4 inch diameter.
WATER PRESSURE	90 to 100 PSI.
CONDITION:	<p>Appears serviceable</p> <p>When the water pressure to a house is over 80 pounds per square inch, the plumbing can be adversely affected. Over a period of time the excessive pressure can cause pipes and valves to leak and gaskets to wear. It can also reduce the life expectancy of the hot water heater. Recommend installation of a Pressure Regulator.</p>

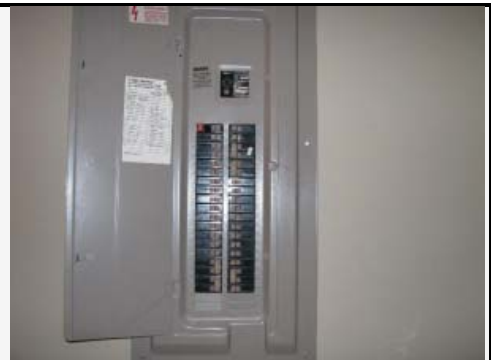
It appears that the A/C electric system is over fused at the breaker panel. Correction is advised. Check the listing on the Condenser unit for the manufacturer's requirements and correct as needed..

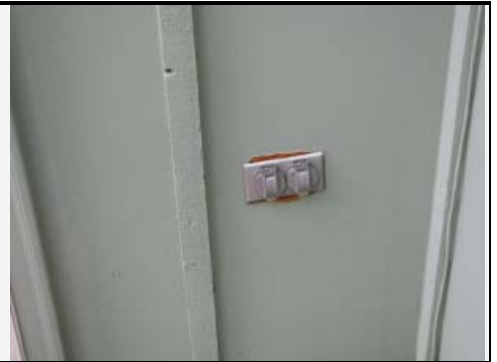
Broken outlet on the deck.
Replacement is advised.
